Reserve Study

*Lake Wallkill
Community*

Reference: **Lake Wallkill Community
Reserve Study – Revision 2
Kipcon Project No. 15729-01**

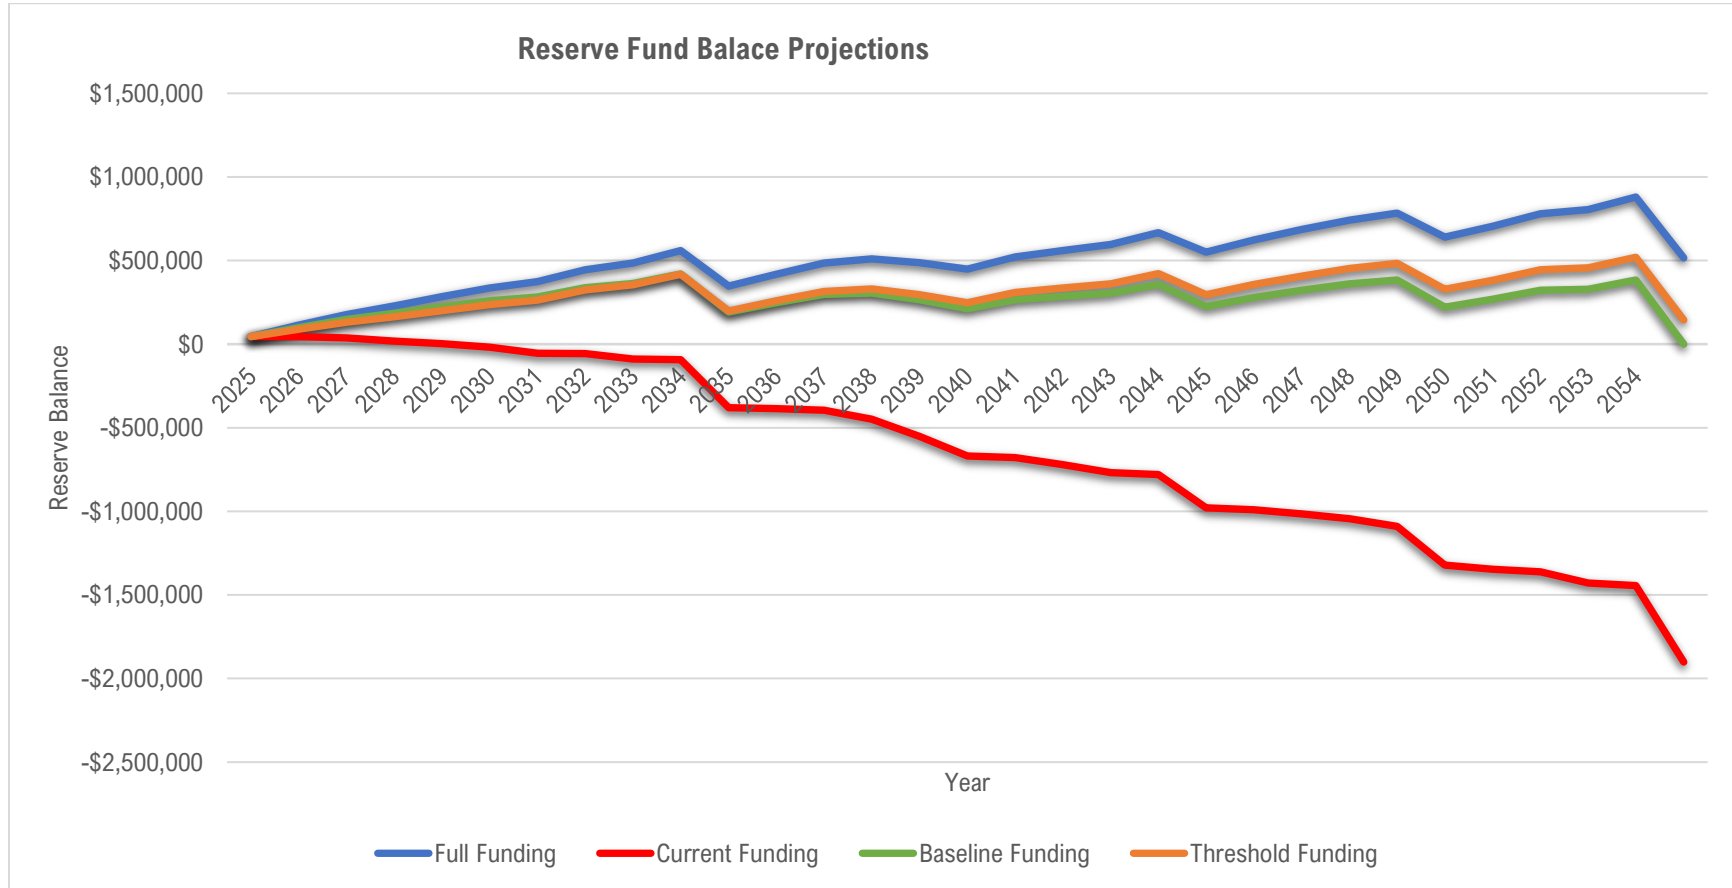
Funding Plan Cash Flow Projections Graph

This Reserve Study indicates that the Association's reserves are underfunded, as it will result in a deficit within the 30-year projection period used in the funding plans and as required within the legislation. The Association is currently contributing \$0 per year to the reserve fund. Should the Association continue funding at their current level, the reserve fund balance will reach a deficit in 2025. Should the Association choose to be fully funding, the recommended annual contribution amount would increase to \$68,806 per year. Kipcon has also shown an incremental increase threshold funding scenario using the contingency balance provided by Robert Smith as the starting annual contribution. This results in an increase in the annual contribution of 5% per year for 6 years starting in 2026 and resulting in an ultimate recommended annual contribution of \$60,304 per year in 2031 and beyond. Please note that this is only one of many funding recommendations that the Association can implement to keep their reserve fund healthy. These should be discussed with Kipcon so the Association can choose the best funding scenario for their community.

The Current Funding Analysis is based on maintaining the current annual funding to determine whether this will cause a deficit at some time during the 30-year cash flow period. If the current annual contribution will eventually cause the fund balance to drop below \$0, underfunding is occurring.
